Rupture of 40-year-old silicone gel breast implants: a case report

Hsin-Hsuan Wu^{1*}, Yu-Tse Weng², Yu-Yu Chou² and Chih-Hsin Wang²

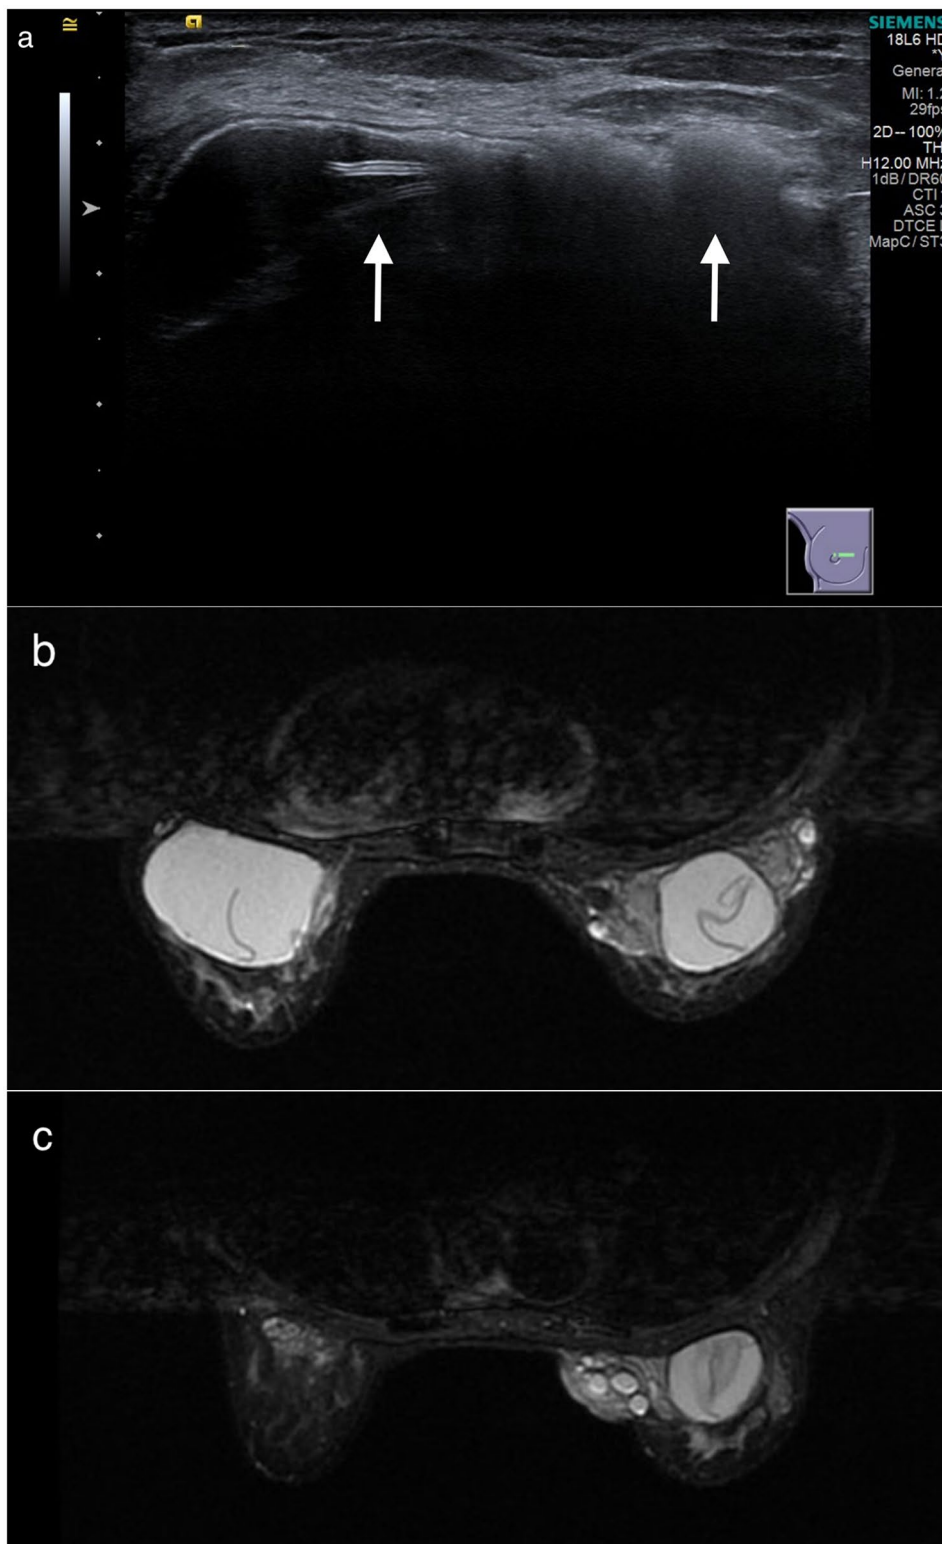
Fig. 2 Diagnosis based on breast sonography and MRI. **(a)** Breast sonography shows intracapsular rupture of the implant. We observed a loss of the integrity of the shell with its fragments inside the implant (stepladder sign, left arrow). We observed an extracapsular rupture of the implant. The evident snowstorm pattern (right arrow) of the silicone outside the shell is characteristic of silicone outside the implant. **(b)** In MRI findings, the 'linguine sign' represents intracapsular rupture. **(c)** MRI shows that the ruptured implant migrated freely beyond the envelope and the fibrous capsule into the surrounding breast tissue. MRI, magnetic resonance imaging

In our case, ultrasonography showed the stepladder and snowstorm signs (Fig. 2a), which indicated intracapsular and extracapsular rupture, respectively. In addition, the 'linguine sign' was present on breast MRI (Fig. 2b) findings, which revealed an intracapsular rupture of both breasts.

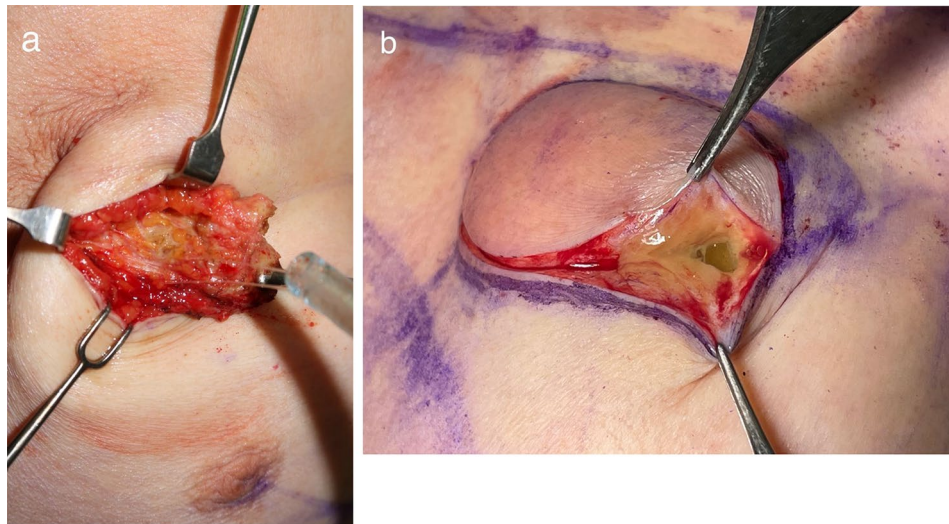
Fig. 3 Operation findings. (a) A sticky gel-like material could be observed diffusing into the surrounding tissues of the left breast. (b) A gel-like material could be observed when dissecting through the upper and inner quadrants lump of the right breast

After obtaining informed consent, the breast tumour in her right breast was excised (Fig. 3b), both breast implants were removed, and capsulectomy was performed for both breasts (excision of the siliconoma of both breasts) in October 2022. The surgery was performed via her previous 3-cm inframammary incision. The implants and their surrounding capsules were removed from the subglandular layer. Next, the silicone gel was spread to the surrounding tissue (Fig. 3). Both

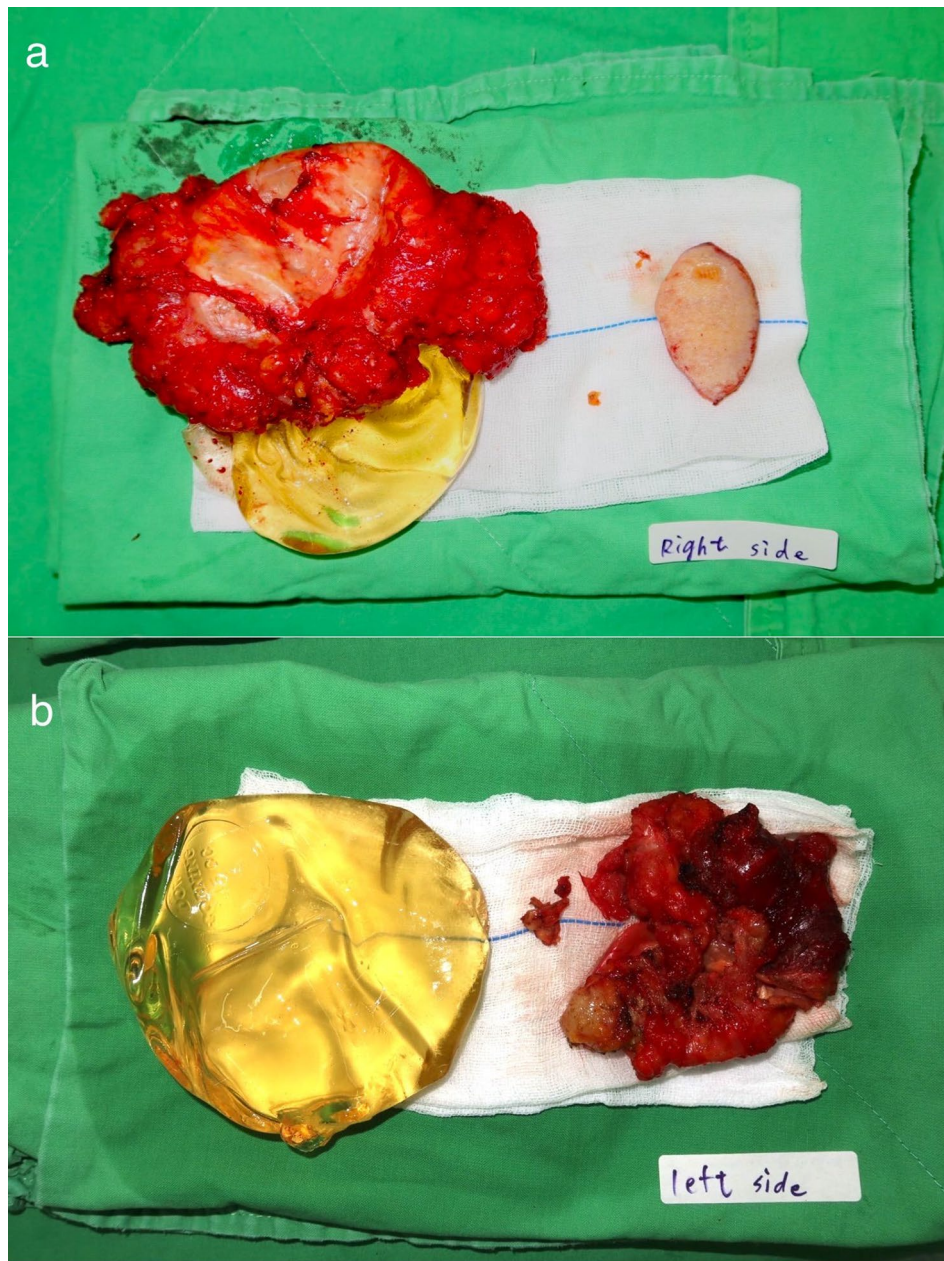
Fig. 4 Removal of implants and tissues during surgery. **(a)** Implants and surrounding tissues formed a capsule, right. **(b)** Ruptured implant and capsule-forming tissue, left

Upon removal, the implants were reported to be 145-cc bilateral breast implants manufactured by Dow Corning Corporation (Fig. 4). The silicone gel was clear and yellowish. The shells were thick, without Dacron fixation patches on the posterior surface. Implants with this configuration were manufactured in the 1980s.
